SNAG LIST

Any client
XX Fairhaven XXstreet
Castleknock
Dublin 15

PROPERTY INSPECTION DATE: /XX/09/19

TYPE: DEVELOPER: N/a
3 bed – house

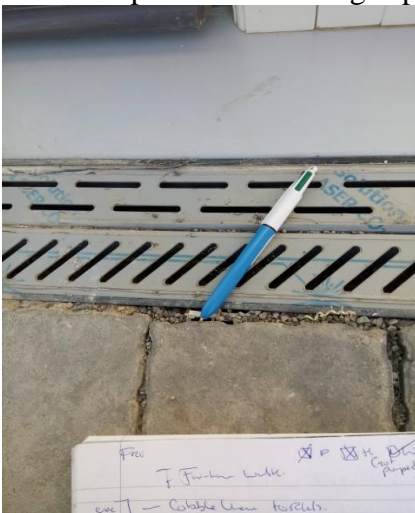
3. ACO Drain channel – remove stickers, clean and remove any debris from channel.
4. Front door leaf – repaint.
5. Re stain/ reseal porch cladding.
6. Front door - touch up mark at side profile of door leaf & clean and paint touch up at framing, jambs (and at window beside).

7. Ground floor bay window l/h/s return window –Dpm showing at l/h/s inner jamb & continue mastic sealant here also. [image relevant above and issue below *]

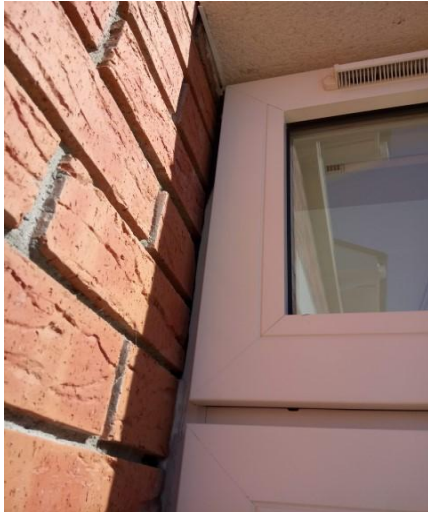
8. Ground floor bay window R/h/s return window –Dpm showing at l/h/s inner jamb & continue mastic sealant here also.
9. Party wall alcove – no gully at grate.
10. Power wash all drive bay and paving upon completion of works.
11. L/h/s boundary railing – multiple chips on paint protective black paint coat. Touch up all along entire length of boundary railing.
12. AJ drain chamber – turn lid, ensure flush and secure with at least 2 fixing points per lid.
13. Bay window – parapet roof – clean off all debris, sand and other material that will aid in the blocking of outlet / down pipe.

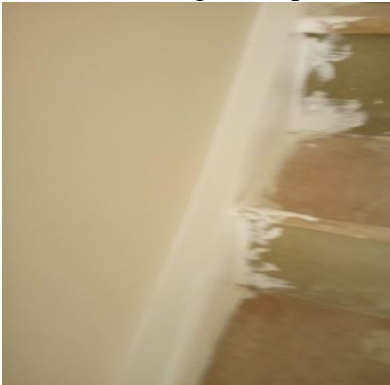
39. Wall at top of stringer – stained and grubby.

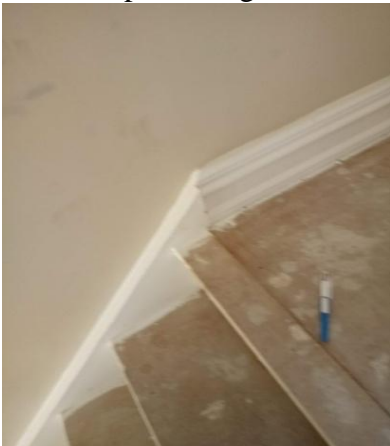
40. 1st flight of stairs – top thread / lip to flooring. Ensure flush.
41. 2nd flight of stairs (return flight) - top thread / lip to flooring. Ensure flush
42. Landing hand rail the same.

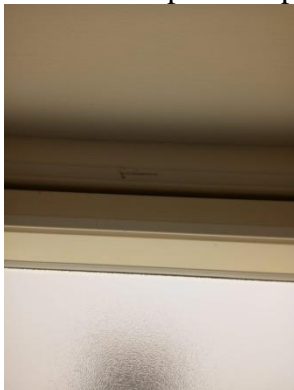
- 60. Window – top rail chipped and damaged. Also clean handle.

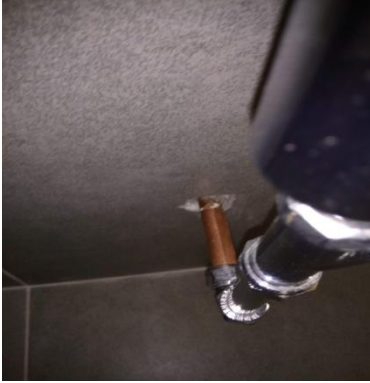
- 66. Toilet bowl loose, secure.
- 67. Ceiling above and to r/h/s of door – paint required on leading edges.

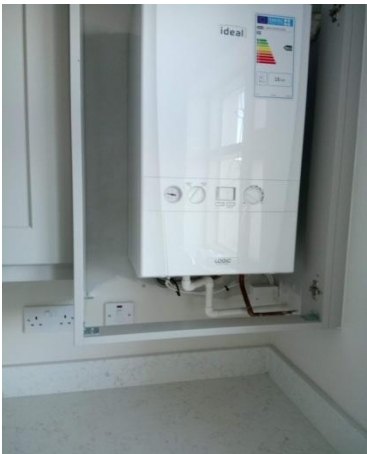
- 81. Connect power to extract hood.
- 82. Fill hole in wall below heating CP panel

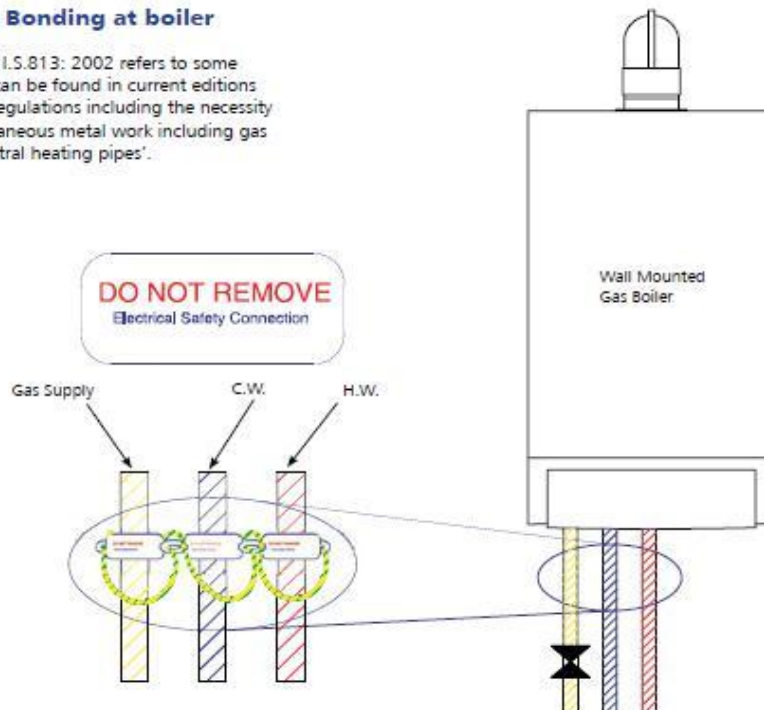
Figure 31:
Cross bonding
arrangement near
boiler

83. No cross bonding and boiler – equipotential bonding . See Bord Gais regs. Below **(note* please email surveyor (michaelf@conspect.ie) if downstream bonding and tagging has take place at hot press or meter box, to negate the equipotential bonding)**

The current edition of I.S.813: 2002 refers to some requirements, which can be found in current editions of the E.T.C.I. wiring regulations including the necessity to cross bond all 'extraneous metal work including gas supply, water and central heating pipes'.

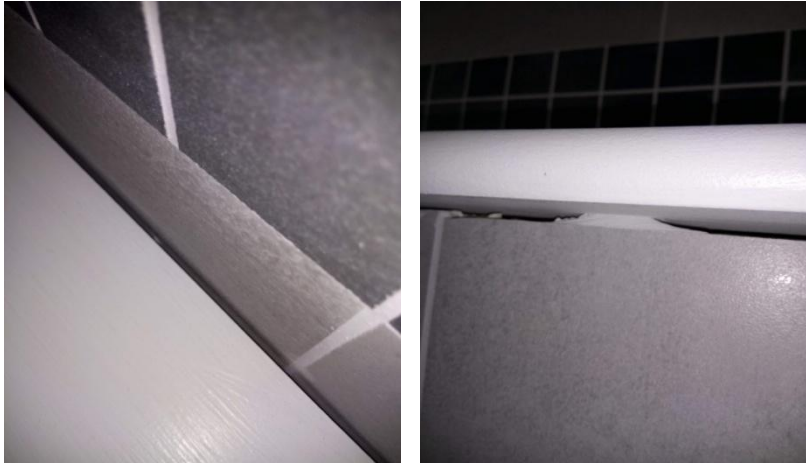
84. Sink – cistern shelf loose, and rocking – lumps of grout and plaster on under side..
Secure and silicone wall joins.

85. Side panel of bath not fitted at mid to end section – kicked inward leaving gaps to floor where chipped tiles are visible. Make good all this area.

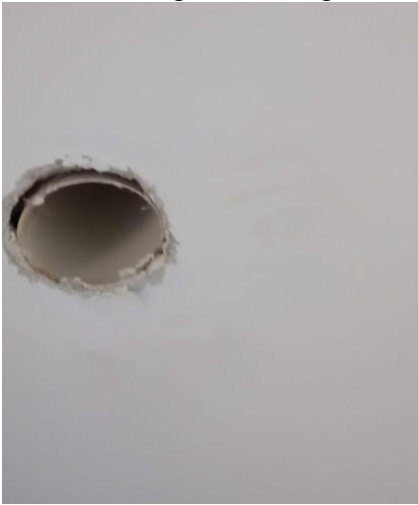
102. Ceiling – fit vent grille.

103. Ceiling – repaint all.
104. Toilet bowl - movement, not secure. Silicone required at back side join to tile.
105. Sink bowl - silicone required at back side join to wall tile. Also at demi sink pedestal, caulk bead to close gap to wall.
106. Window – casement opening, no safety catch fitted.

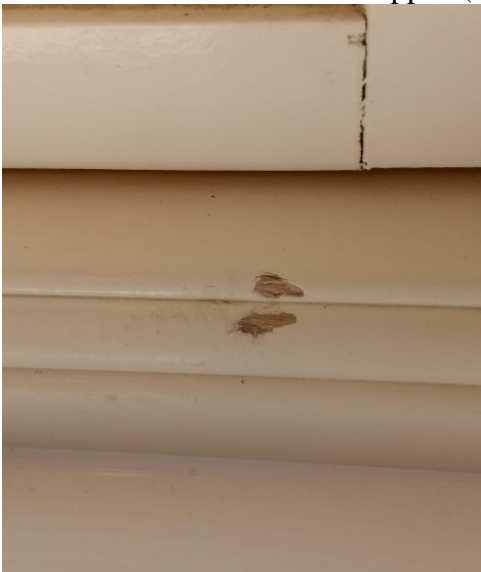
111. Window – r/h/s jamb, large chip / damage at top.

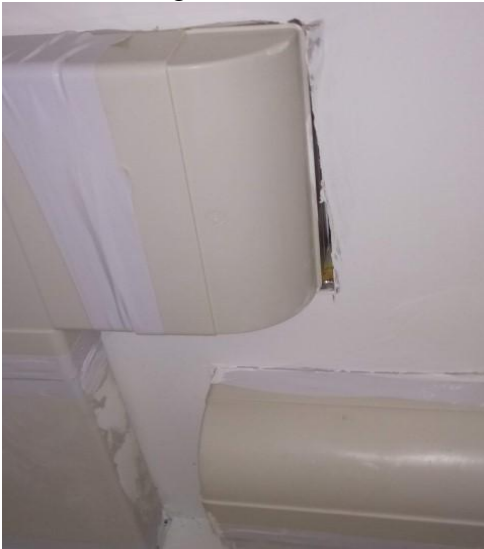
- 118. Aperture in wall, close up.
